Manhole Inspection Summary

Manhole # S37W1_021MH

Insp Date: **11/19/07 1:46 PM**

Location Address: **3560 3rd St**

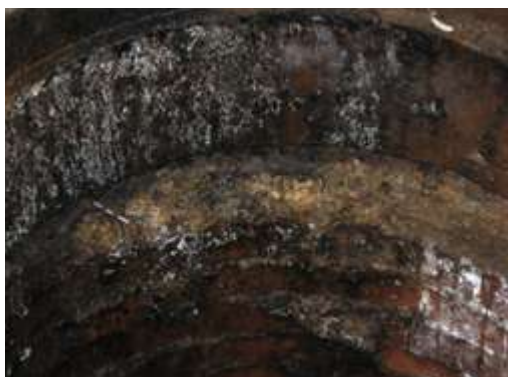
Defect 1

Condition: ☐ Sound ☒ **Cracked** ☐ Root Intrusion ☐ Loose Brick ☐ Deteriorated

Infiltration: ☐ None ☐ Joint ☒ **Cracks** ☒ **Mortar** ☐ Roots ☐ Wall

Chimney infiltration

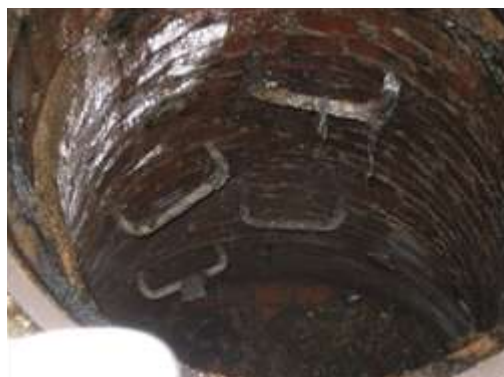
Defect 3

Surcharge ☒ **Evidence Of Surcharge** Depth: **1** (ft.) ☐ Active Surcharge Present

Evidence of surcharge on steps

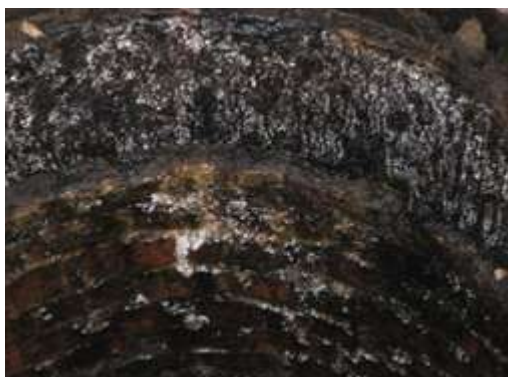
Defect 2

Chimney mortar/infiltration

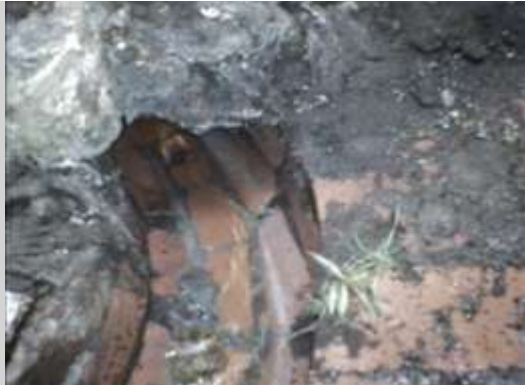
12 O'Clock Outflow

10 in. Circular Gravity Sewer
Pipe Out @ 12 O'Clock

Pipe Height: **9.6** (in.) Rod and Bar (Angled)
Pipe Material: **Clay** ☐ Pipe Lined
Invert Depth: **8.10** (ft.) Flow Characteristics: **Fast**
Deposits: ☐ None ☐ Mud ☐ Grassy ☒ **Debris** ☐ Grease
Silt Depth: **0.5** (in.) Deposits Extent: **Light**
Infiltration: **None** Pipe Seal Cond: **Sound**

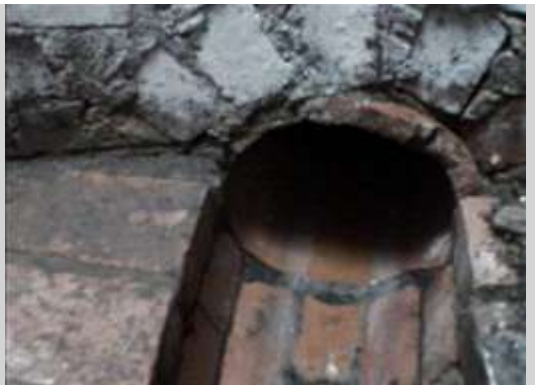
7 O'Clock Inflow

10 in. Circular Gravity Sewer
Pipe In @ 7 O'Clock

Pipe Height: **10.8** (in.) Rod and Bar (Angled)
Pipe Material: **Clay** ☐ Pipe Lined
Invert Depth: **7.88** (ft.) Flow Characteristics: **Fast**
Deposits: ☐ None ☐ Mud ☒ Grassy ☒ **Debris** ☐ Grease
Silt Depth: **0.5** (in.) Deposits Extent: **Light**
Infiltration: **None** Pipe Seal Cond: **Cracked**
